Subject: 2010300074 - Winnebago County  
Soil Component Remedial Action Completion Report  
Source Area 4, Southeast Rockford Groundwater Contamination Superfund Site  
Rockford, Winnebago County, Illinois  
Superfund/Technical

**Soil Component Remedial Action  
Completion Report**

Source Area 4  
Southeast Rockford Groundwater  
Contamination Superfund Site

FINAL REPORT

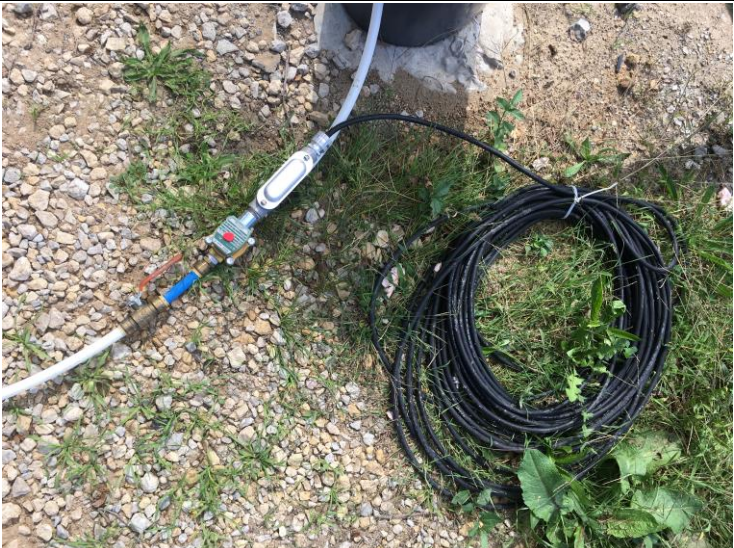
<b>Photo No.</b> <b>2</b>	<b>Date:</b> 10/03/2016	<b>Time:</b> 1234

<b>Direction:</b> N/A			
<b>Description:</b>  Solenoids were placed on the drip tubes attached to Zone 1 and Zone 2 electrodes. These solenoids will release water to the sand pack on select electrodes if the sand starts to dry up and current starts to drop.

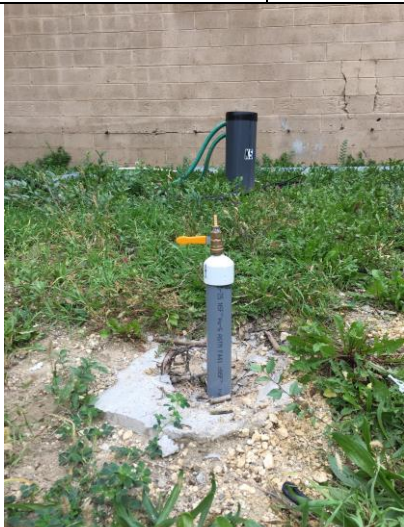
<b>Photographic Log</b>			Project: <b>IEPA Rockford Area 4</b>	Project Number: <b>80527</b>
<b>Photo No.</b> <b>1</b>	<b>Date:</b> 10/04/2016	<b>Time:</b> 0913

<b>Direction:</b> East				
<b>Description:</b>  Sample ports were placed on top off all of the VP (Vapor Point) wells.

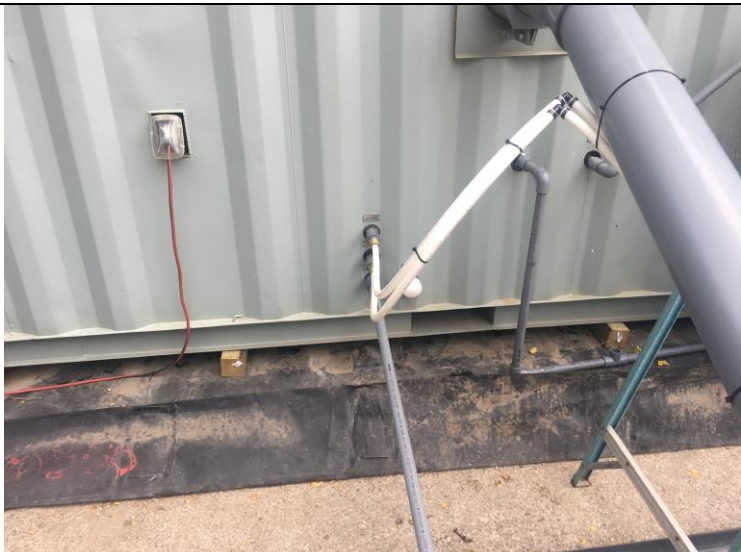
<b>Photo No.</b> <b>2</b>	<b>Date:</b> 10/04/2016	<b>Time:</b> 1010

<b>Direction:</b> South			
<b>Description:</b>  Drip loop was connected to the condenser unit with 1" PEX tubing.

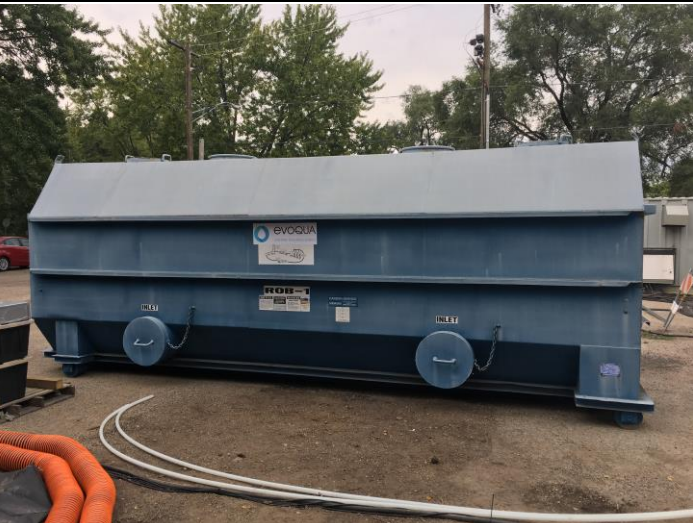
Photographic Log			Project: IEPA Rockford Area 4	Project Number: 80527
Photo No. 1	Date: 10/05/2016	Time: 0929

Direction:  West				
Description:  VGAC (Vapor Granular Activated Carbon) arrives on site from Evoqua Water Technologies. The rolloff is comprised of 2 internal chambers with 2 inlets located on the east side of the vessel and 2 outlets that are located on top of the vessel.

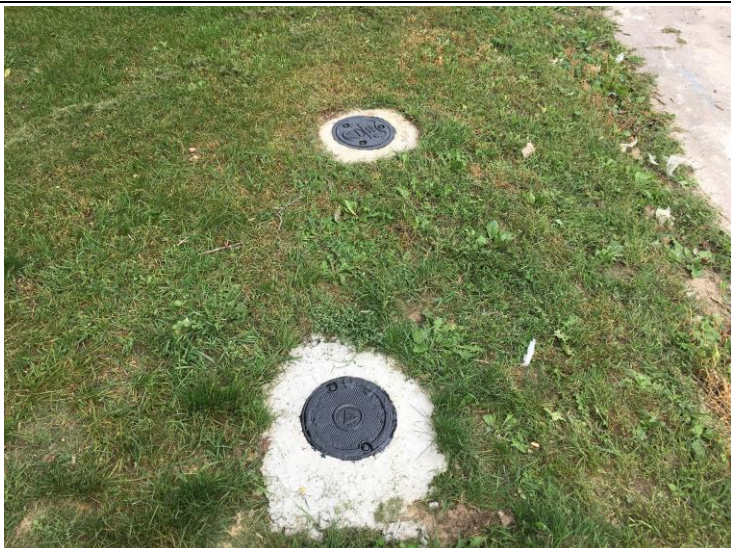
<b>Photo No.</b> <b>2</b>	<b>Date:</b> 10/05/2016	<b>Time:</b> 0941

<b>Direction:</b>  South			
<b>Description:</b>  TRS sprayed Flex Seal on the VP and groundwater monitoring well located in the adjacent property across Marshall Street. This was done to mitigate any potential voltage issues and to keep the public safe because of their location outside of the perimeter fence.

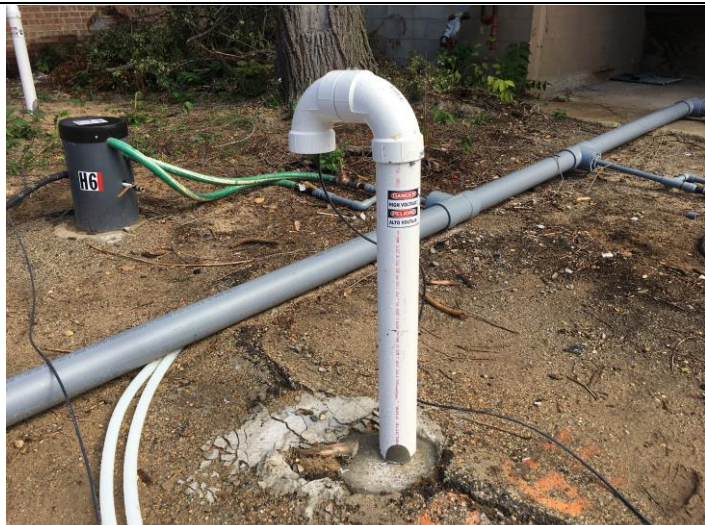
<b>Photo No.</b> <b>3</b>	<b>Date:</b> 10/05/2016	<b>Time:</b> 1141

<b>Direction:</b>  Northeast			
<b>Description:</b>  TRS placed PVC over sleeves on GWP wells with a 90 degree fitting on top to keep rain water from getting into the well.

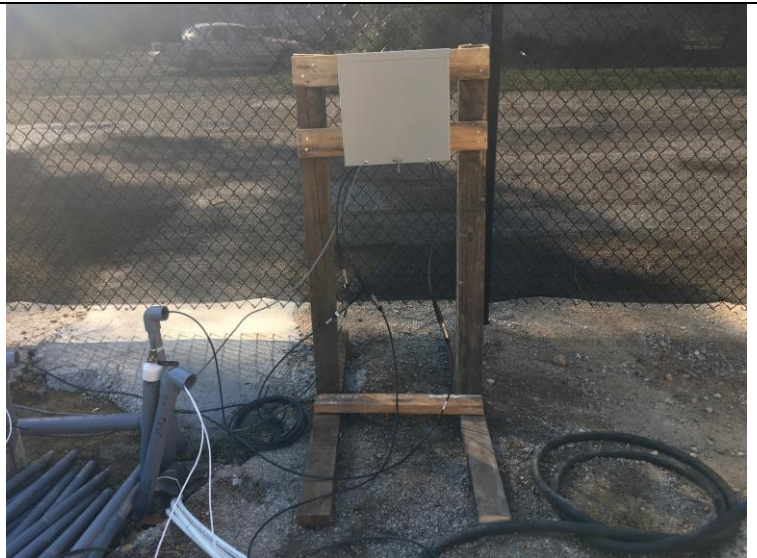
Photo No. 4	Date: 10/05/2016	Time: 1512
Direction:  West		
Description:  TRS had to build stands for 2 electrical boxes that were placed on site. These boxes are used as extenders so that new cable would not need to be placed.

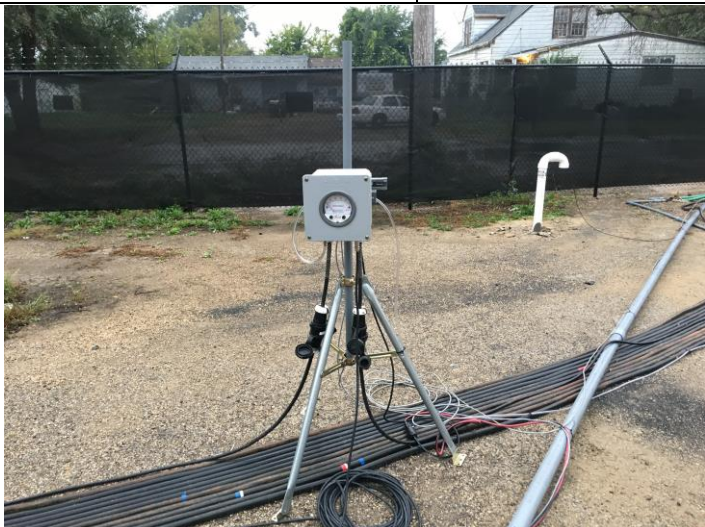
<b>Photographic Log</b>			Project: <b>IEPA Rockford Area 4</b>	Project Number: <b>80527</b>
<b>Photo No.</b> <b>1</b>	<b>Date:</b> 10/06/2016	<b>Time:</b> 0929

<b>Direction:</b> West				
<b>Description:</b>  A pressure interlock box was placed on site. This gauge monitors the pressure in the pipes and will shut down the system if pressure goes below or above certain pressures.

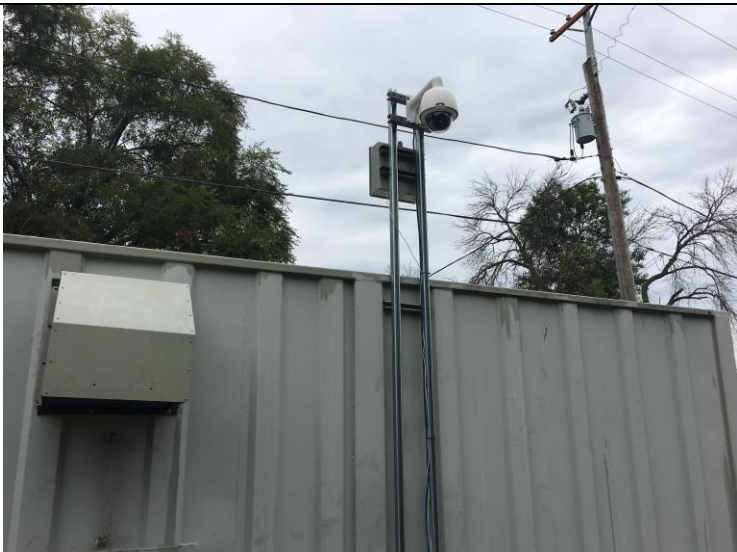
<b>Photo No.</b> <b>2</b>	<b>Date:</b> 10/06/2016	<b>Time:</b> 0941

<b>Direction:</b> West			
<b>Description:</b>  TRS installed a 360 degree camera on top of the east side of the PCU so that they can see what is going on remotely on site if they get an alarm. They will check this camera before starting the system remotely incase somebody is on site or there is a major visible issues with the equipment on site.

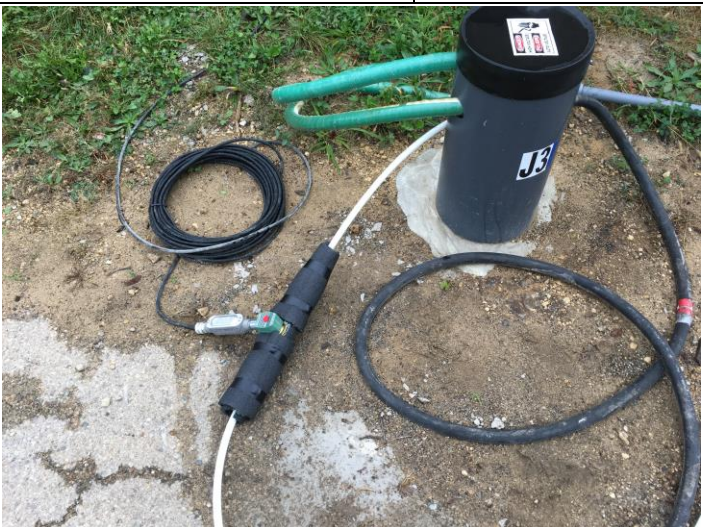
<b>Photographic Log</b>			Project: <b>IEPA Rockford Area 4</b>	Project Number: <b>80527</b>
<b>Photo No.</b> <b>1</b>	<b>Date:</b> 10/07/2016	<b>Time:</b> 0846

<b>Direction:</b>  N/A				
<b>Description:</b>  The solenoid valves in Zone 2 were wrapped with foam because it was discovered during a voltage survey that the metal valves were recording a voltage of 40 Volts which is greater than what they are allowed (10 V inside of fence and 5 V outside of fence).

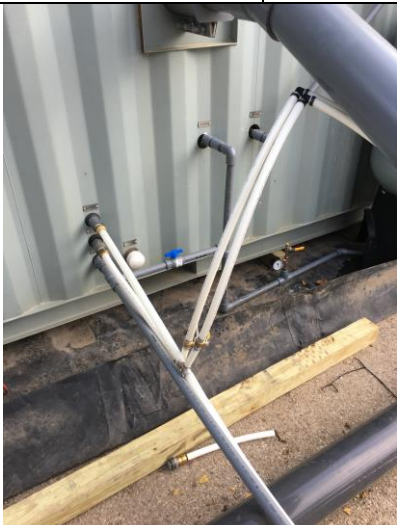
Photographic Log			Project: IEPA Rockford Area 4	Project Number: 80527
Photo No. 1	Date: 10/10/2016	Time: 1632

Direction:				
South				
Description:				
TRS replaced the 3/4" PEX with 1" PEX for the drip loop and the cooling loop (which goes to EX-003). They also placed "T" fittings in the cooling loop line so that they could connect the drip line so that all of the lines connect at the condenser unit.

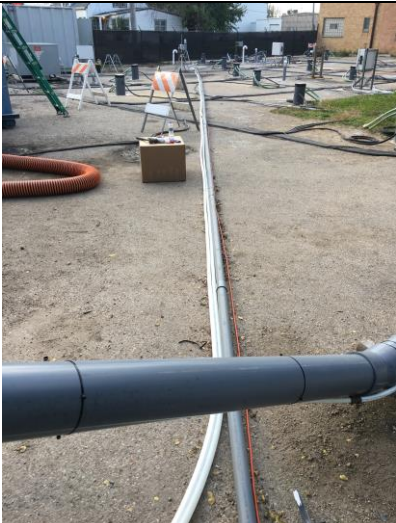
<b>Photo No.</b> <b>2</b>	<b>Date:</b> 10/10/2016	<b>Time:</b> 1632

<b>Direction:</b>  Northwest			
<b>Description:</b>  1" PEX for the cooling loop that runs down the blowdown line to the trench.

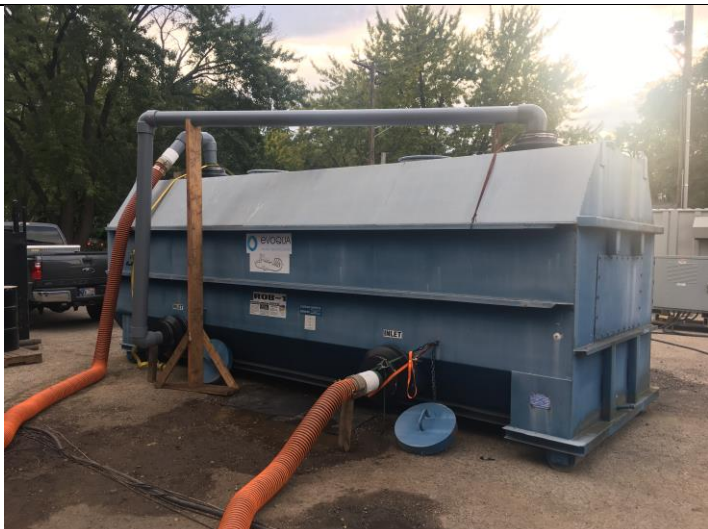
<b>Photo No.</b> <b>3</b>	<b>Date:</b> 10/10/2016	<b>Time:</b> 1727

<b>Direction:</b>  Southwest			
<b>Description:</b>  The blower out CPVC pipe was connected to the inlet of the northern most chamber of the VGAC system. The outlet was then CPVC piped to the second inlet. The second outlet was then fitted so that it could be connected to 6" hose to an exhaust stack that was attached to the PCU. Each outlet and inlet was fitted with a Fernco fitting to reduce the 15" opening to a 6" opening.

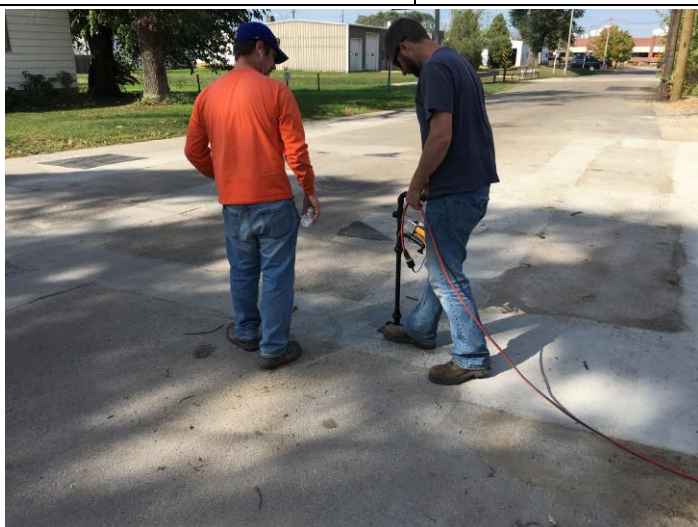
Photographic Log			Project: IEPA Rockford Area 4	Project Number: 80527
Photo No. 1	Date: 10/11/2016	Time: 1412

Direction:  Northwest				
Description:  TRS performing a voltage survey of concrete in Marshall St. Voltage readings ranged between 8 and 9 Volts. Issues will have to be mitigated because per TRS protocol no readings can be above 5 V.

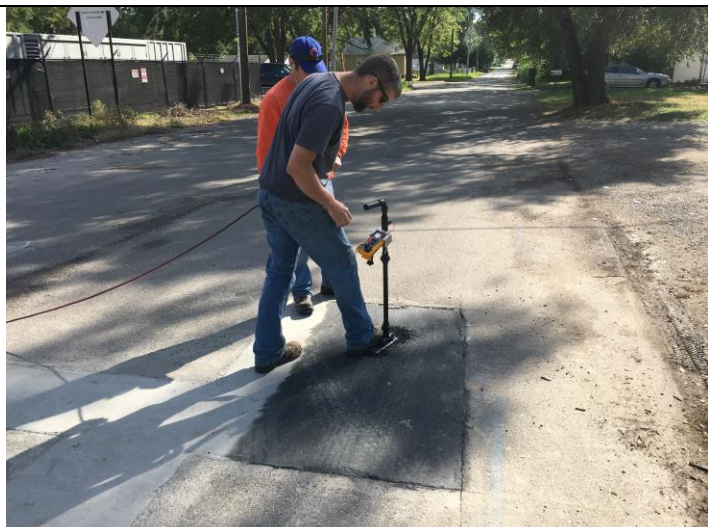
<b>Photo No.</b> <b>2</b>	<b>Date:</b> 10/11/2016	<b>Time:</b> 1413

<b>Direction:</b>  South			
<b>Description:</b>  Concrete was first sprayed with Flex Seal. TRS checks dry and wet conditions. Flex Seal did not work so TRS will have to do more mitigation in Marshall St.

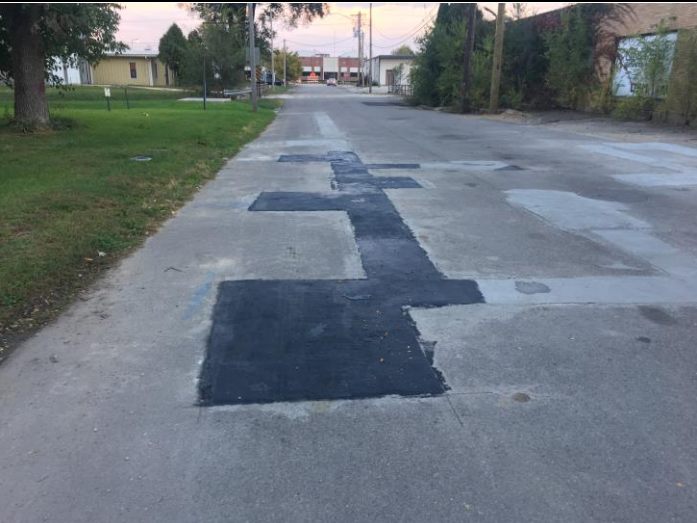
Photographic Log			Project: IEPA Rockford Area 4	Project Number: 80527
Photo No. 1	Date: 10/12/2016	Time: 0736

Direction:				
North				
Description:				
Leak Seal was spread on concrete over “B” row of electrodes as well as trench between “B” and “C” rows of electrodes. The Leak Seal came in a can and was spread using a paint roller.

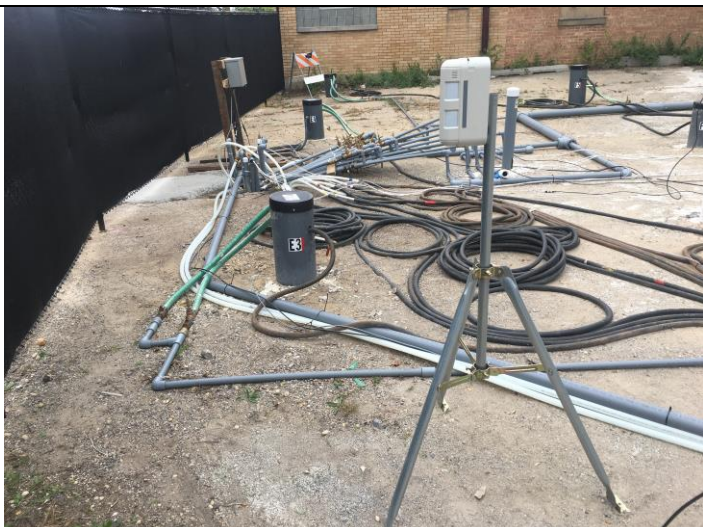
<b>Photo No.</b> <b>2</b>	<b>Date:</b> 10/12/2016	<b>Time:</b> 1052

<b>Direction:</b>  North			
<b>Description:</b>  New sensors were placed on site around the perimeter of the site. These sensors will shut down the PCU which shuts down the entire system if the sensor line is broken.

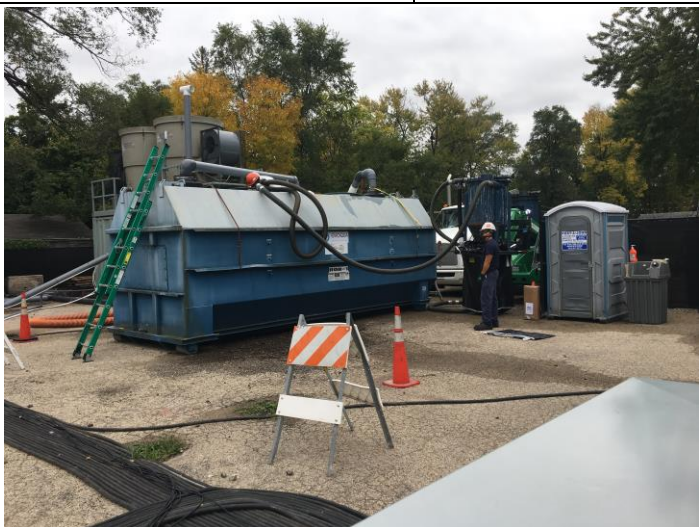
<b>Photographic Log</b>			Project: <b>IEPA Rockford Area 4</b>	Project Number: <b>80527</b>
<b>Photo No.</b> <b>1</b>	<b>Date:</b> 10/17/2016	<b>Time:</b> 1049

<b>Direction:</b> Southeast				
<b>Description:</b>  Evoqua was on site to seal the VGAC vessel that was leaking from the plates on the north and south ends of the rolloff. They started by removing the carbon with a vacuum and then taking the steel plates and rubber gaskets off.

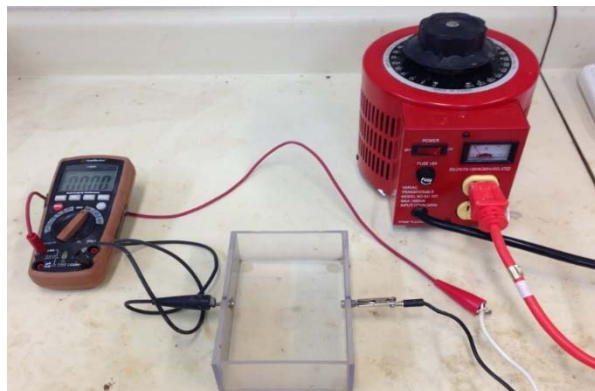
**Figure 10:** Two-Electrode Soil Box

The resistivity of the soil samples tested by ASTM G187-12a ranged between approximately 23 and 47 ohm-meters (ohm-m). These values are consistent with values expected for moist sand. The values also match up well with the 34 ohm-m value that TRS used in the preliminary design for this project. A summary of the resistivity data are summarized below in Table 2.

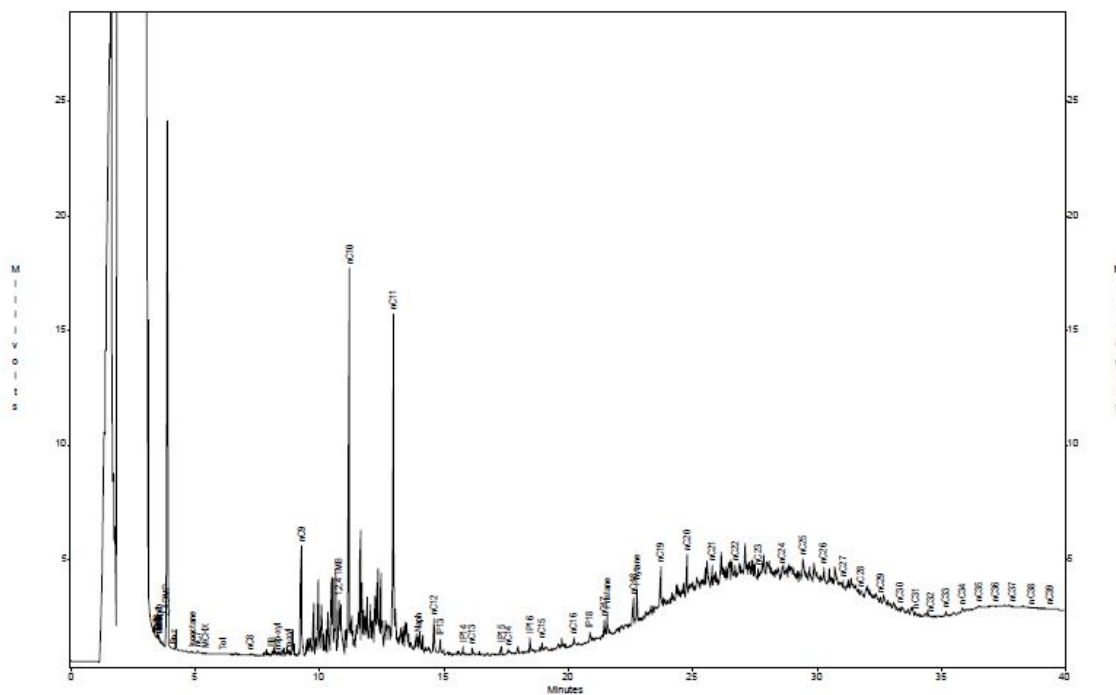
**Figure 13:** Fingerprint Analysis for Site Water Sample

Note that in each sample there are 2 very distinct petroleum hydrocarbon patterns. Between the 10 and 15 minute retention time there are a series of peaks that represent the C8 to C12 hydrocarbon range that is characteristic of gasoline. The lack of peaks in the early portion of the chromatogram indicate that the gasoline has been highly weathered over time.

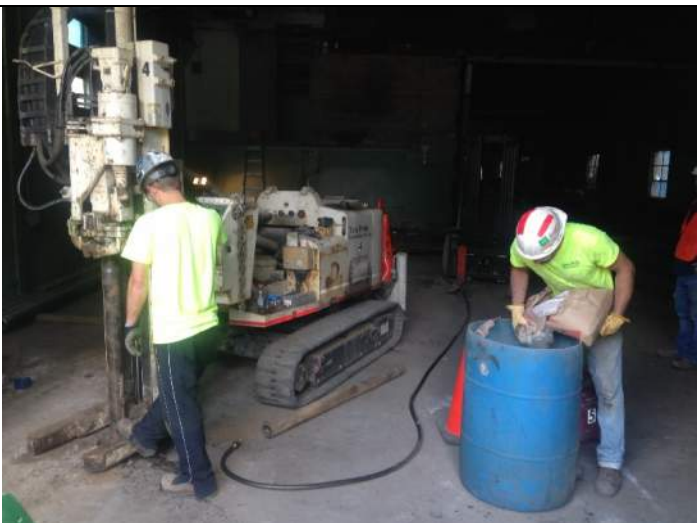
Photo No. <b>2</b>	Date: 07/11/2016	Time: 1321

Direction: North			
Description:  Terra Probe used a Geoprobe 6620 track-mounted rig to install multi-phase extraction (MPE) electrodes inside of existing building.

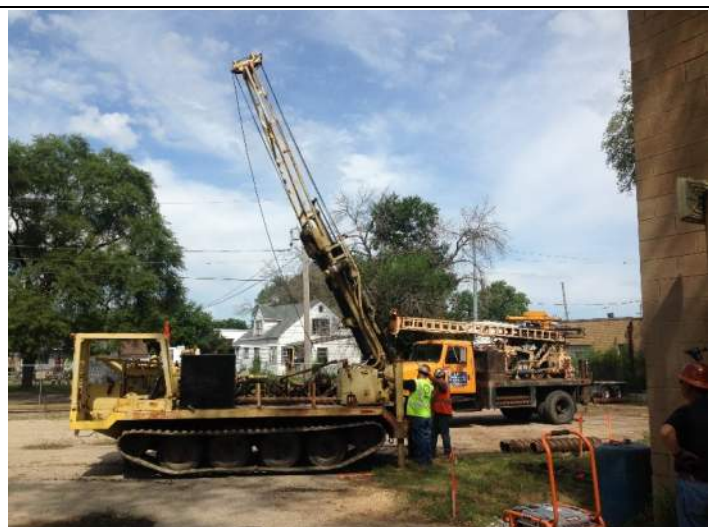
<b>Photo No.</b> <b>3</b>	<b>Date:</b> 07/20/2016	<b>Time:</b> 1039

<b>Direction:</b>  West			
<b>Description:</b>  K&S Engineers began installing borings outside of the building using a Central Mine Equipment Co. 850 steel track-mounted drilling rig, but ceased using this drill rig and began using a Diedrich-120 truck-mounted drill rig to avoid damaging asphalt pavement.

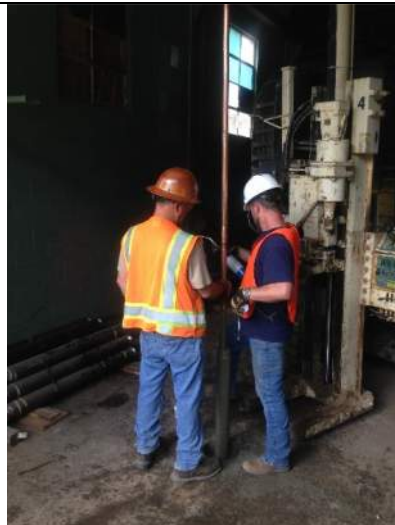
<b>Photo No.</b> <b>4</b>	<b>Date:</b> 07/11/2016	<b>Time:</b> 1341
<b>Direction:</b> North		
<b>Description:</b>  After the Schedule 40 black iron steel pipe was installed, a copper groundwater extraction pipe was lowered into the hole and screwed into the bottom of a cap placed on top of the black iron pipe. The copper extraction pipe was placed approximately 6 inches into the top of groundwater.

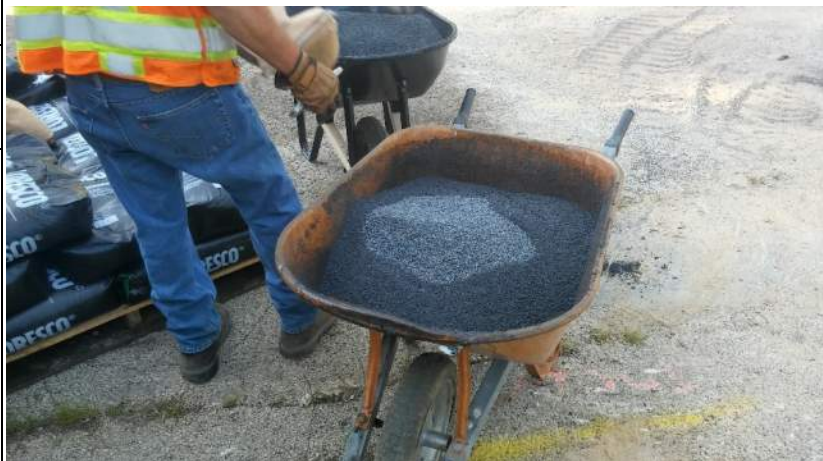
<b>Photo No.</b> <b>5</b>	<b>Date:</b> 08/09/2016	<b>Time:</b> 0845
<b>Direction:</b> N/A		
<b>Description:</b>  After installation of black iron steel pipe, batches of graphite/iron shot were mixed in a wheelbarrow. The mixture consisted of one 50-pound bag of iron shot for every three 50-pound bags of SWS Earth Contact Backfill graphite. Batch was well mixed and hydrated with water from a hose on site.

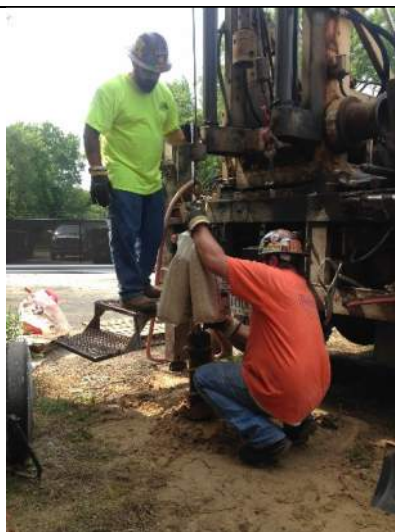
<b>Photo No.</b> <b>6</b>	<b>Date:</b> 08/02/2016	<b>Time:</b> 1121
<b>Direction:</b> South		
<b>Description:</b>  In Zones 2 and 3, #4 silica/bluestone sand was poured into the annulus on top of the installed graphite/iron shot mixture.

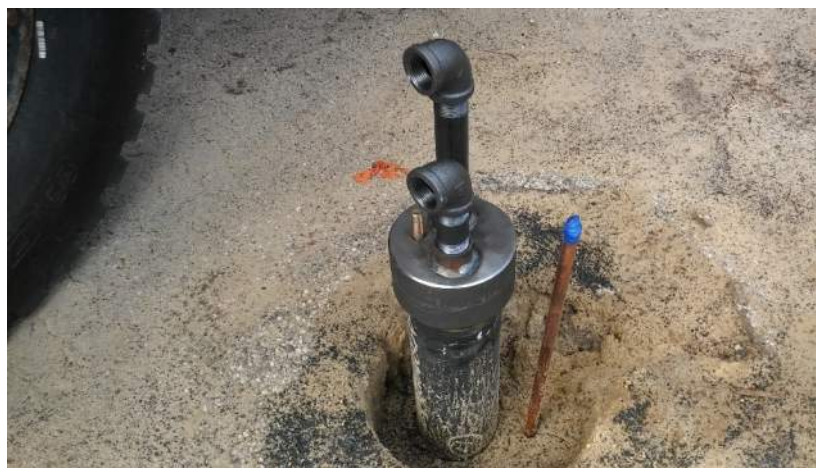
<b>Photo No.</b> <b>8</b>	<b>Date:</b> 08/08/2016	<b>Time:</b> 1613
<b>Direction:</b> N/A		
<b>Description:</b>  After the cap was screwed on to the black iron steel pipe, a 10-inch CPVC sleeve was placed around the electrode and held into place with Type I Portland cement.

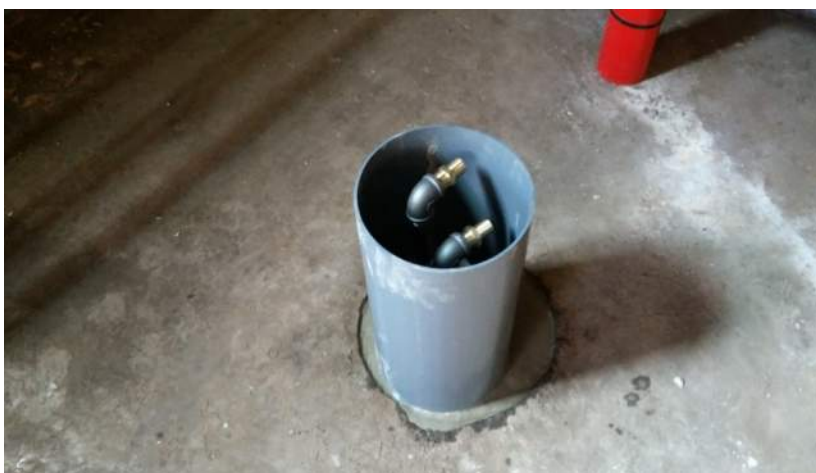
<b>Photo No.</b> <b>9</b>	<b>Date:</b> 08/18/2016	<b>Time:</b> 0957
<b>Direction:</b> North		
<b>Description:</b>  After CPVC oversleeve was set, two 1.5-inch diameter holes were drilled into oversleeve and 4-foot long sections of 1-inch diameter thermally insulated, chemical-resistant tubing was connected to the electrode cap.

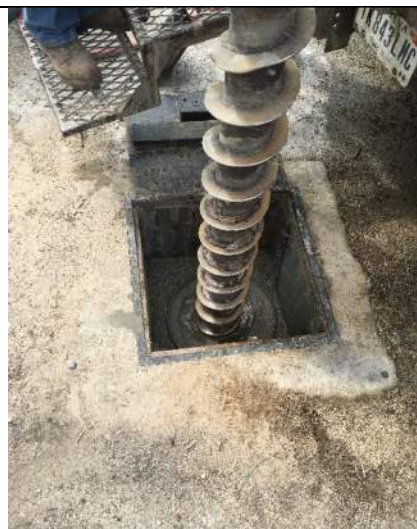
<b>Photo No.</b> <b>11</b>	<b>Date:</b> 08/29/2016	<b>Time:</b> 1112
<b>Direction:</b>		
<b>Description:</b>  K&S over-drilling multi-level well (MLW-01) located on site. The well was grouted from bottom to top of casing then over-drilled to 10 feet below ground surface. Concrete was then poured into well vault and settled to 2.5 feet below ground surface.

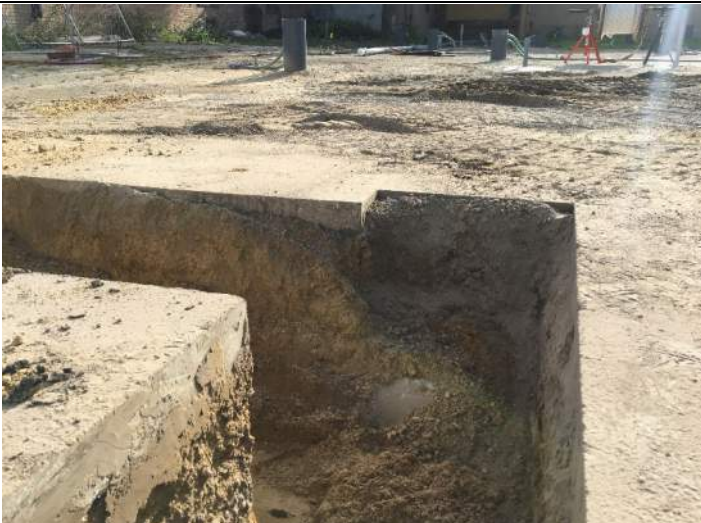
<b>Photo No.</b> <b>14</b>	<b>Date:</b> 08/31/2016	<b>Time:</b> 0857

<b>Direction:</b>  East			
<b>Description:</b>  A stormwater pipe was encountered while digging a north-south trench between the "C" and "D" row of electrodes. After discussions, a new trench was sawcut 4 feet to the east of planned trench.

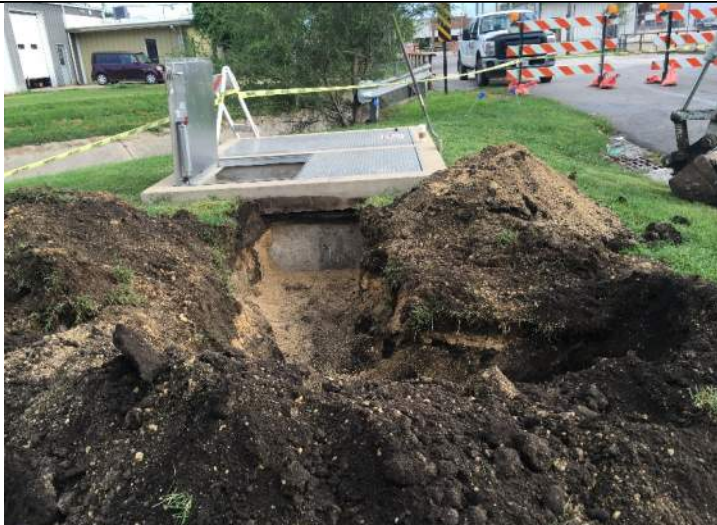
<b>Photo No.</b> <b>15</b>	<b>Date:</b> 09/01/2016	<b>Time:</b> 0816
<b>Direction:</b>  North		
<b>Description:</b>  TRS excavated near Bodine's groundwater extraction vault so that 2 holes could be drilled into the side for placement of the blowdown line and a communications cable.

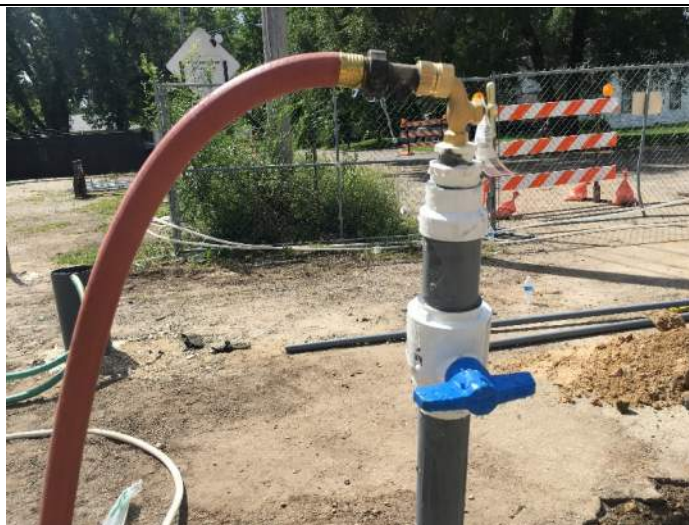
<b>Photo No.</b> <b>16</b>	<b>Date:</b> 09/01/2016	<b>Time:</b> 1156
<b>Direction:</b> South		
<b>Description:</b>  The blowdown pipe was pressure tested by placing valves on each side and filling the pipe with water so that the internal pressure was between 40 and 70 psi.

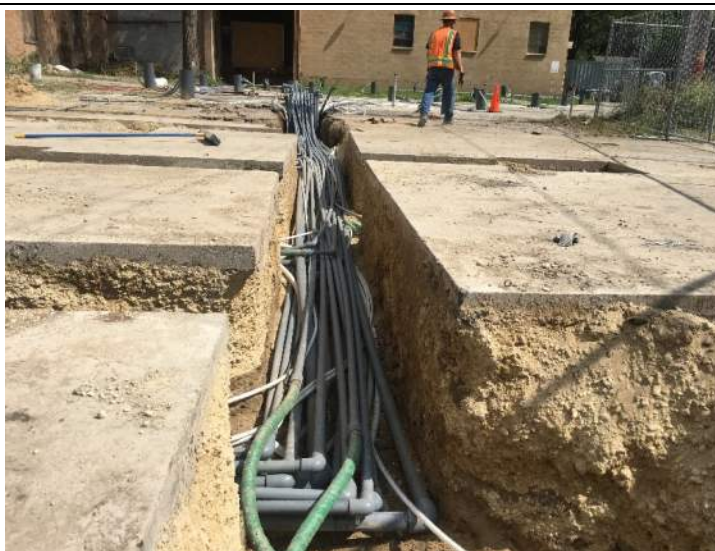
<b>Photo No.</b> <b>18</b>	<b>Date:</b> 09/06/2016	<b>Time:</b> 1335
<b>Direction:</b> East		
<b>Description:</b>  East-west trench with all of the underground piping.

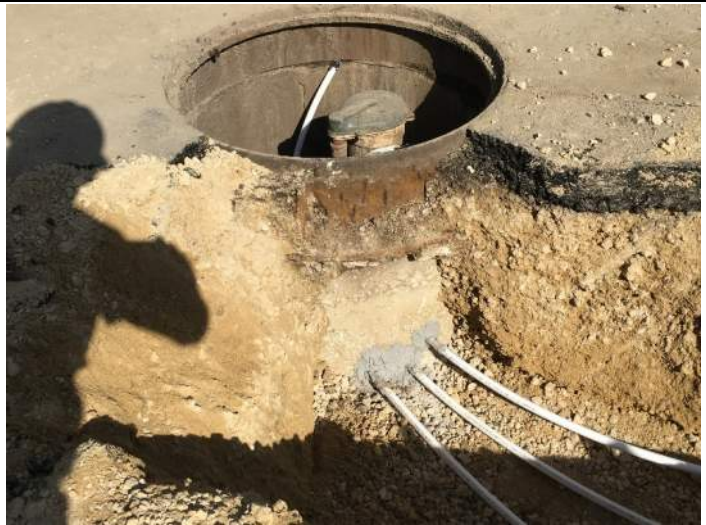
<b>Photo No.</b> <b>19</b>	<b>Date:</b> 09/06/2016	<b>Time:</b> 1554
<b>Direction:</b> East		
<b>Description:</b>  Three 1.25-inch holes were drilled into side of EW003 vault. Two holes for the cooling loop that will be placed in EW-3 and 1 hole for a temperature probe. Holes were sealed with hydraulic cement.

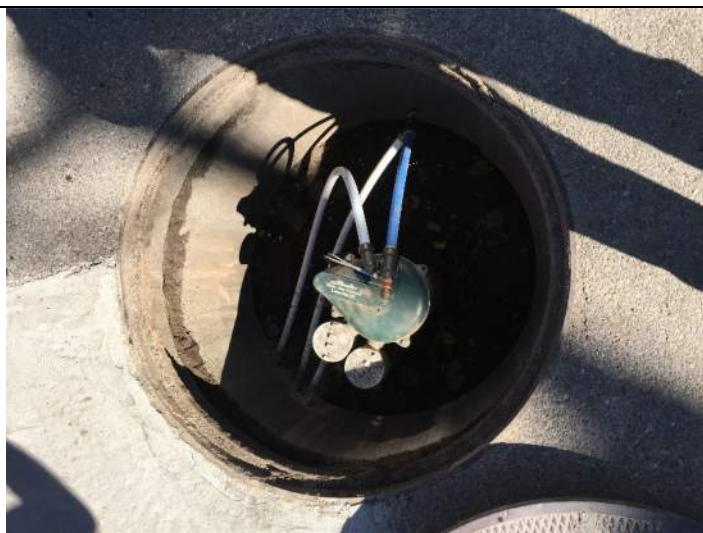
<b>Photo No.</b> <b>28</b>	<b>Date:</b> 09/27/2016	<b>Time:</b> 1127
<b>Direction:</b>  N/A		
<b>Description:</b>  Drip loop was installed in EW003 to 42 feet below ground surface and consisted of 0.75-inch PEX tubing to 35 feet and 0.5-inch PEX tubing from 35 feet to 42 feet. Two holes were drilled in the plastic cover so that the tubing could be brought into the manhole.

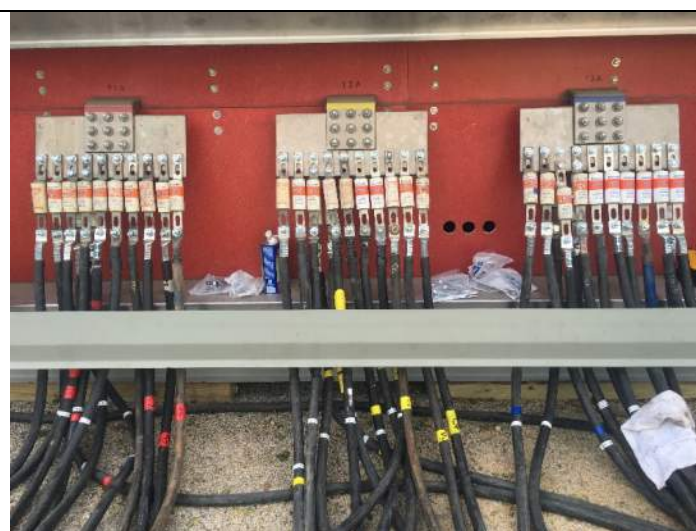
<b>Photo No.</b> <b>29</b>	<b>Date:</b> 09/27/2016	<b>Time:</b> 1606
<b>Direction:</b>  West		
<b>Description:</b>  All electrode cables were attached to Amp-Traps and attached to phase plates on the PCU.

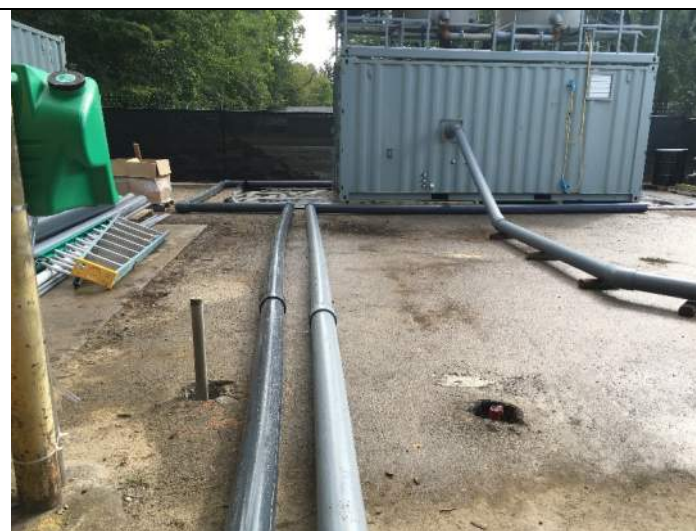
<b>Photo No.</b> <b>30</b>	<b>Date:</b> 09/27/2016	<b>Time:</b> 1459
<b>Direction:</b>  South		
<b>Description:</b>  6-inch PVC pipe ran out of the south side of the condenser to the blower and then from the blower was connected to the VGAC vessel.

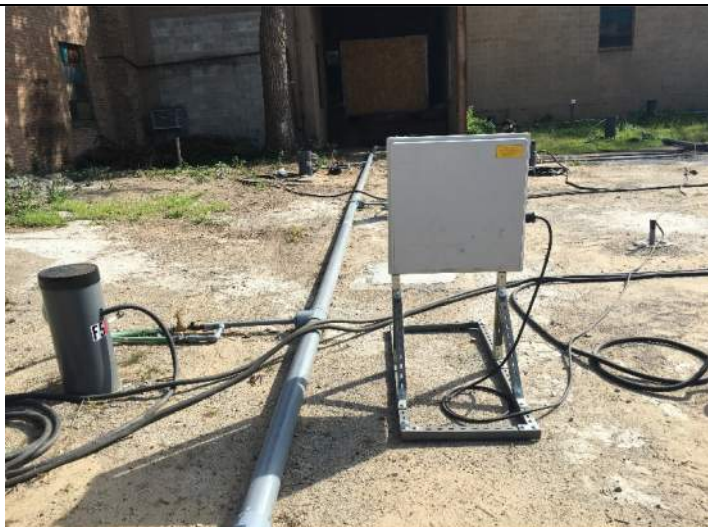
<b>Photo No.</b> <b>31</b>	<b>Date:</b> 09/29/2016	<b>Time:</b> 1052

<b>Direction:</b>  East			
<b>Description:</b>  One of two RTD (temperature control boxes) placed on site. All of the temperature sensors were connected to one of the two boxes which then connected to the computer on site.

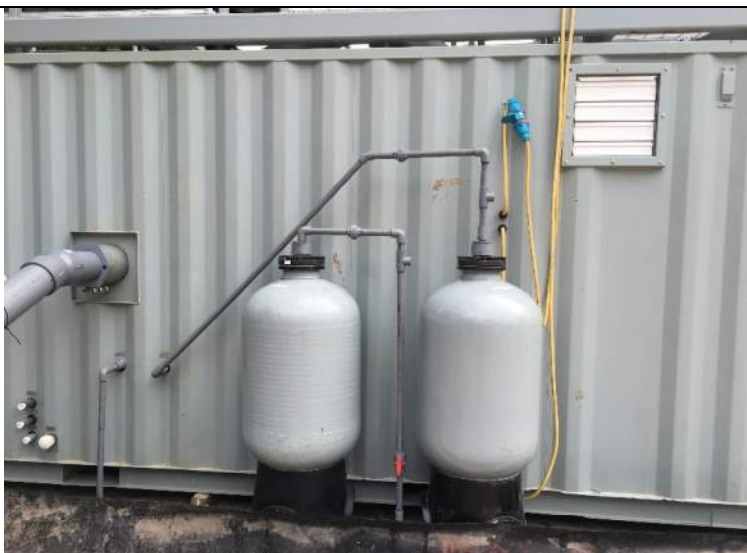
<b>Photo No.</b> <b>32</b>	<b>Date:</b> 09/29/2016	<b>Time:</b> 1639
<b>Direction:</b>  South		
<b>Description:</b>  The primary (left) and secondary (right) LGAC (Liquid Granular Activated Carbon) vessels were hard piped to the condenser unit using 1-inch CPVC pipe.

A photograph showing two large, white, cylindrical Liquid Granular Activated Carbon (LGAC) vessels mounted on a metal frame. The vessels are connected by a network of grey CPVC pipes. A large grey pipe enters from the left, and a yellow hose is connected to the top of the right vessel. The background is a light-colored, corrugated metal wall with a small window. The ground in the foreground is dark and appears to be a rooftop or industrial area.

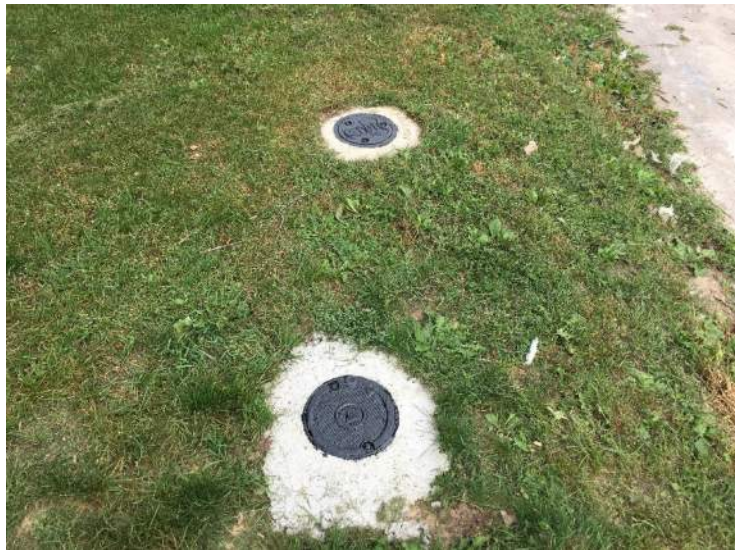
<b>Photo No.</b> <b>34</b>	<b>Date:</b> 10/05/2016	<b>Time:</b> 0941
<b>Direction:</b>  South		
<b>Description:</b>  TRS sprayed Flex Seal on the VP-C2 and groundwater monitoring well located in the adjacent property across Marshall Street. This was done to mitigate any potential voltage issues in public areas.

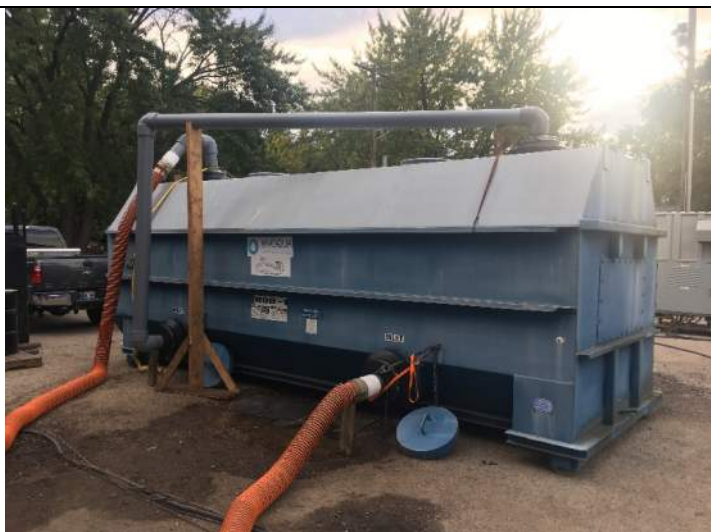
<b>Photo No.</b> <b>38</b>	<b>Date:</b> 10/10/2016	<b>Time:</b> 1727
<b>Direction:</b>  Southwest		
<b>Description:</b>  The blower out CPVC pipe was connected to the inlet of the northern most chamber of the VGAC system. The outlet was then CPVC piped to the second inlet. The second outlet was then fitted so that it could be connected to 6-inch hose to an exhaust stack that was attached to the PCU. Each outlet and inlet was fitted with a Fernco fitting to reduce the 15-inch opening to a 6-inch opening.

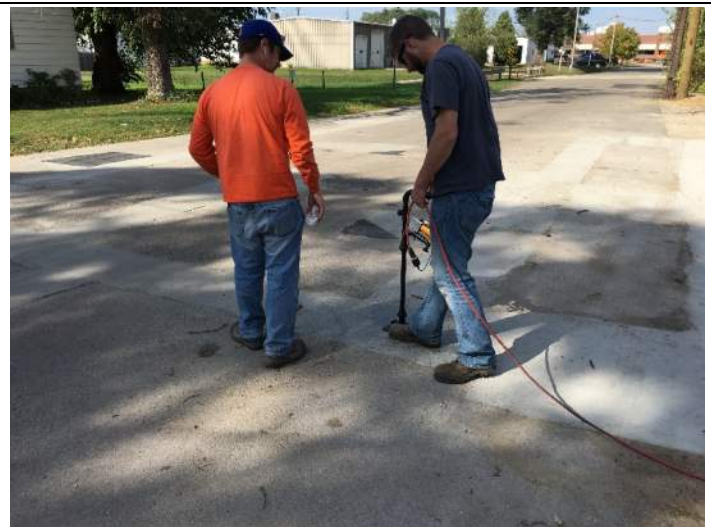
<b>Photo No.</b> <b>39</b>	<b>Date:</b> 10/11/2016	<b>Time:</b> 1412
<b>Direction:</b>  Northwest		
<b>Description:</b>  TRS performed a voltage survey of concrete in Marshall St. Voltage readings ranged between 8 and 9 volts.

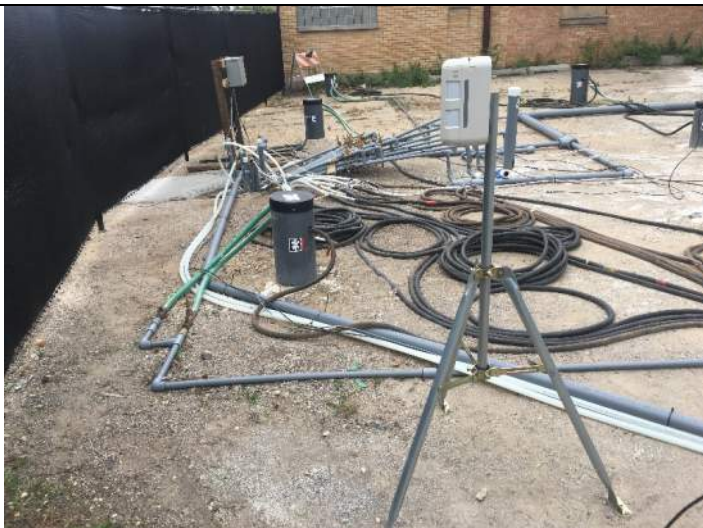
<b>Photo No.</b> <b>40</b>	<b>Date:</b> 10/12/2016	<b>Time:</b> 1052

<b>Direction:</b>  North			
<b>Description:</b>  New sensors were placed on site around the perimeter of the site. These sensors will shut down the PCU which then discontinues power application to the treatment volume.

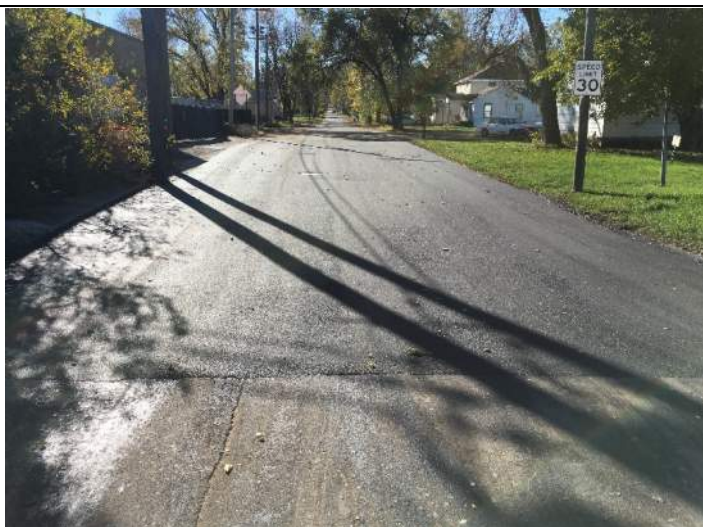
<b>Photo No.</b> <b>42</b>	<b>Date:</b> 11/10/2016	<b>Time:</b> 1007
<b>Direction:</b>  South		
<b>Description:</b>  On November 9, 2016, a 40-foot by 121.5-foot section of Marshall Street was milled and repaved to fully mitigate voltage potential issues.

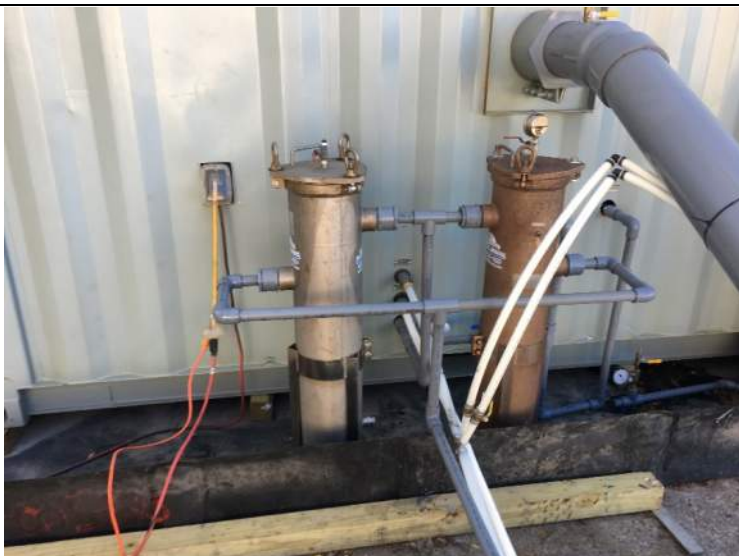
<b>Photo No.</b> <b>43</b>	<b>Date:</b> 11/10/2016	<b>Time:</b> 1008
<b>Direction:</b>  South		
<b>Description:</b>  Two 25-micron bag filters were installed in parallel in order to address a sulfate reducing bacteria issues with the process water.

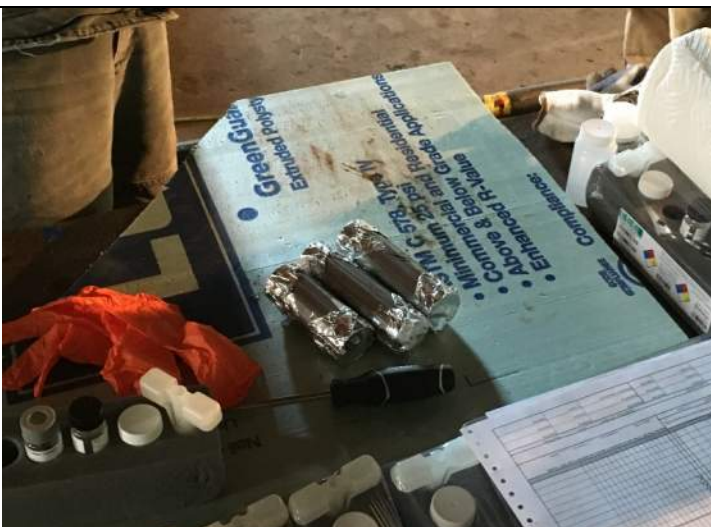
<b>Photo No.</b> <b>47</b>	<b>Date:</b> 12/13/2016	<b>Time:</b> 1417

<b>Direction:</b>  N/A			
<b>Description:</b>  Soil at each sampling depth was collected inside of 2-inch hollow stainless steel tubes. After the tubes were removed from the auger, each end was sealed with tape.

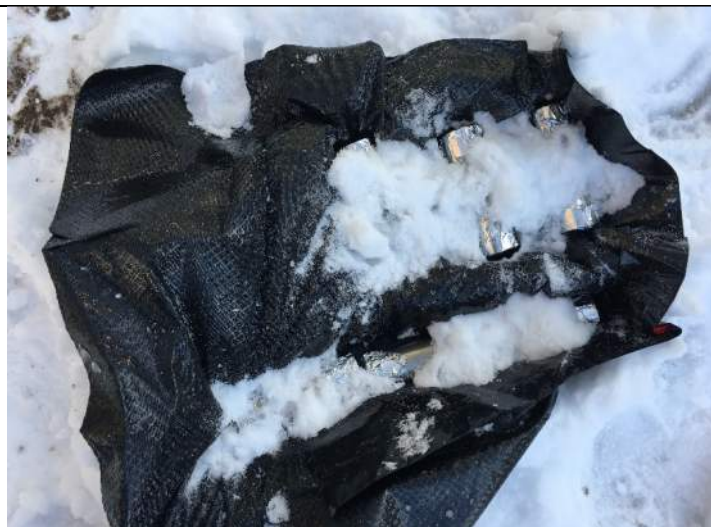
<b>Direction:</b>  N/A			
<b>Description:</b>  After the sampling tubes were removed from the auger and completely sealed, they were cooled to ambient temperature so that the soil could be sampled.

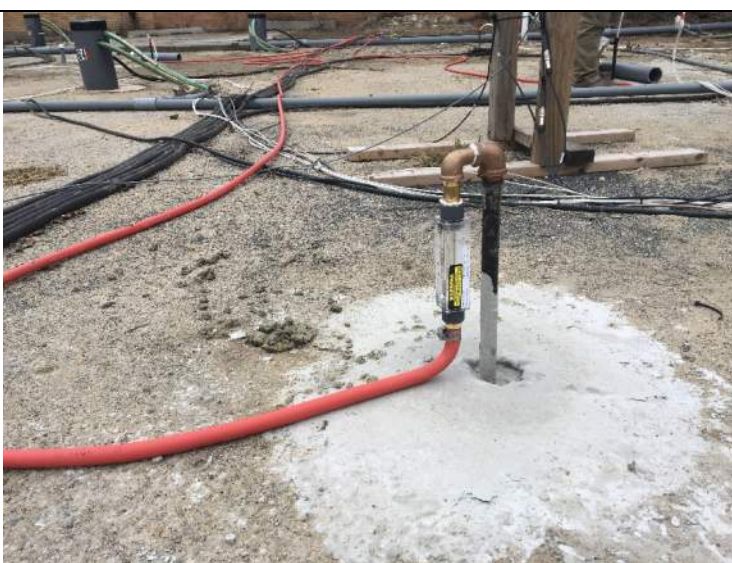
<b>Photo No.</b> <b>50</b>	<b>Date:</b> 01/24/2017	<b>Time:</b> 1415
<b>Direction:</b>  North		
<b>Description:</b>  After the second round of soil confirmation sampling, a steam sparging system was installed at the site to help remediate PCE at the bottom interval of the treatment zone. Air was supplied to each of the 3 steam sparge points with a 5-hp air compressor and rubber hose. A flow meter was attached to each point.

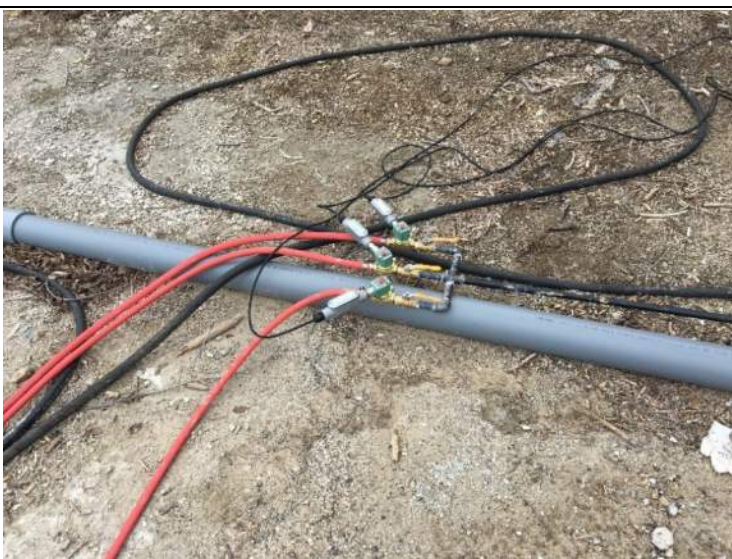
<b>Photo No.</b> <b>51</b>	<b>Date:</b> 01/24/2017	<b>Time:</b> 1428
<b>Direction:</b>  N/A		
<b>Description:</b>  A solenoid valve was attached to each of the three steam sparge points which allowed for air addition to each point in 1 hour cycles.

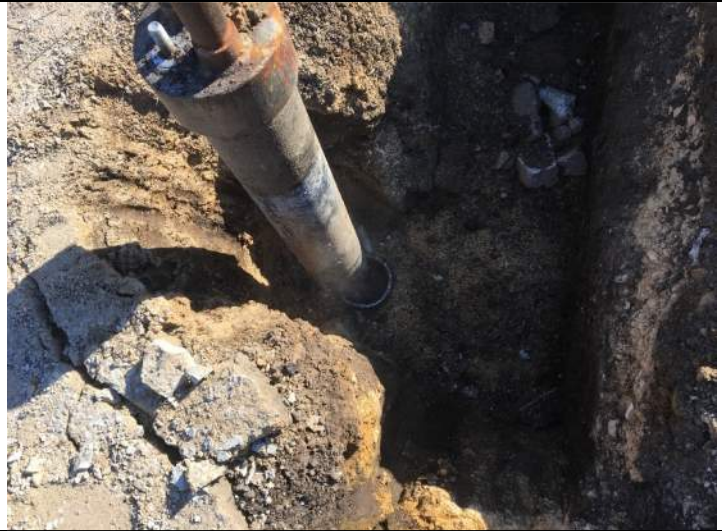
<b>Photo No.</b> <b>52</b>	<b>Date:</b> 03/15/2017	<b>Time:</b> 0957
<b>Direction:</b>  N/A		
<b>Description:</b>  After all RGs had been achieved at Area 4 and the Illinois EPA gave the go ahead, TRS began demobilizing equipment off site. All MPE electrodes, VPs, GWPs, and TMPs were abandoned by the use of a mini excavator to expose the pipe below existing ground surface. Once the pipes were exposed, Jackson Welding used a torch to cut the pipes at least 2 feet below ground surface.
